# Service manual

# **VRV IV+ Heat Pump**

Service manual VRV IV+ Heat Pump

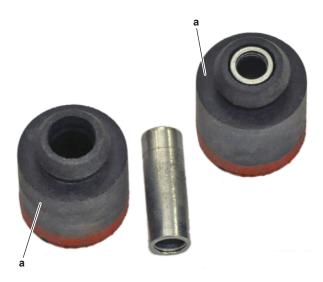
- 2 Open the compressor insulation.
- 3 Check the compressor dampers and piping for any damage.

a Damper

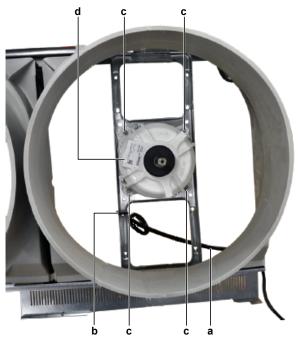
- 1 Remove the propeller fan blade assembly from the DC fan motor assembly, see "Repair procedures" on page 115.
- 2 Disconnect the DC fan motor connector from the fan inverter PCB.
- 3 Unlock the ferrite bead.
- 4 Cut the tie strap.
- 5 Detach the DC fan motor cable.

- a Fan motor cable
- b Tie wrapc Screw
- c Screwd Fan motor
- u Tan motor
- 6 Remove the 4 screws that fix the DC fan motor assembly.
- 7 Remove the DC fan motor assembly from the unit.
- 8 To install the DC fan motor assembly, see "Repair procedures" on page 115.

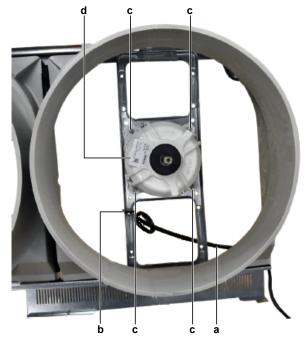
- 1 Remove the propeller fan blade assembly from the DC fan motor assembly, see "Repair procedures" on page 117.
- 2 Remove the required plate work, see "3.13 Plate work" on page 118.
- 3 Disconnect the DC fan motor connector from the fan inverter PCB.
- 4 Unlock the ferrite bead.
- 5 Cut the tie strap.
- 6 Detach the DC fan motor cable.

- a Fan motor cable
- **b** Tie wrap
- **c** Screw
- d Fan motor
- 7 Remove the 4 screws that fix the DC fan motor assembly.

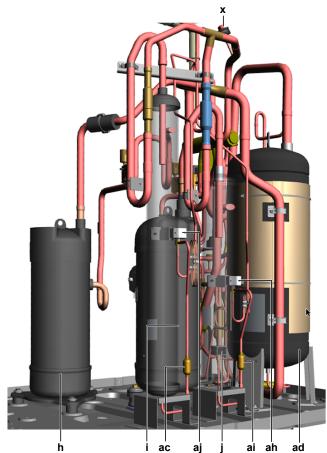
#### 6.4.3 Component overview: RXYQ18~20U units

- Switchbox, for details see "6.5 Switchbox overview" on page 182.
- Fan motor M1F b
- Fan motor M2F
- Liquid cooling expansion valve Y3E
  Compressor (M1C) discharge thermistor R21T
- Compressor (M2C) discharge thermistor R22T

- Compressor M1C + body thermistor R8T Compressor M2C + body thermistor R9T
- Oil return valve Y2S
- Filter
- Filter
- Charge port
- Liquid pipe thermistor, outdoor heat exchanger R4T
- Gas stop valve
- Liquid stop valve
- Service port
- Gas pipe thermistor, sub-cool heat exchanger R6T

- Sub-cool expansion Valve Y2E Main expansion valve Y1E
- Low pressure sensor S1NPL u
- 4-way valve Y1S
- High pressure switch S2PH
- Refrigerant high pressure sensor S1NPH
- Accumulator inlet thermistor R3T
- Oil separator
- High pressure switch S1PH aa
- ab Liquid pipe thermistor, sub-cool heat exchanger R5T
- ac
- ad Accumulator
- Heat exchanger
- De-icer thermistor, outdoor heat exchanger R7T af
- ag ah Filter
- Oil return valve Y3S
- ai Filter
- Oil return valve Y4S

- Switchbox, for details see "6.5 Switchbox overview" on page 182.
- Fan motor M1F
- Fan motor M2F
- Liquid cooling expansion valve Y3E
  Compressor (M1C) discharge thermistor R21T
  Compressor (M2C) discharge thermistor R22T
  Oil separator

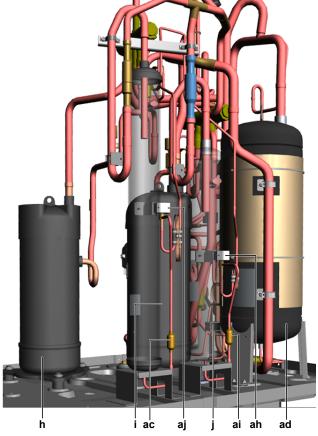
- Switchbox, for details see "6.5 Switchbox overview" on а page 182.
- b Fan motor M1F
- Fan motor M2F
- Liquid cooling expansion valve Y3E
- Compressor (M1C) discharge thermistor R21T
- Compressor (M2C) discharge thermistor R22T
- Oil separator
- Compressor M1C + body thermistor R8T Compressor M2C + body thermistor R9T
- Oil return valve Y2S
- Filter
- Filter
- Charge port Liquid pipe thermistor, outdoor heat exchanger R4T Gas stop valve
- Liquid stop valve
- Service port
- Gas pipe thermistor, sub-cool heat exchanger R6T
- Sub-cool expansion Valve Y2E

- Main expansion valve Y1E t
- Low pressure sensor S1NPL
- 4-way valve Y1S
- High pressure switch S2PH
- Refrigerant high pressure sensor S1NPH Accumulator inlet thermistor R3T
- y z Oil separator
- High pressure switch S1PH aa
- ab Liquid pipe thermistor, sub-cool heat exchanger R5T
- Filter
- ad Accumulator
- ae
- Heat exchanger De-icer thermistor, outdoor heat exchanger R7T af
- Filter ag
- Oil return valve Y3S aĥ
- Filter
- Oil return valve Y4S
- 4-way valve Y5S Equalisation pipe
- al

- Switchbox, for details see "6.5 Switchbox overview" on page 182. Fan motor M1F
- Fan motor M2F
- Liquid cooling expansion valve Y3E
- Compressor (M1C) discharge thermistor R21T Compressor (M2C) discharge thermistor R22T
- Oil separator
- Compressor M1C + body thermistor R8T Compressor M2C + body thermistor R9T
- Oil return valve Y2S
- Filter
- Charge port Liquid pipe thermistor, outdoor heat exchanger R4T
- Gas stop valve Liquid stop valve
- Service port
- Gas pipe thermistor, sub-cool heat exchanger R6T
- Sub-cool expansion Valve Y2E
